Palestinian Presidential Committee
For

The Restoration of the Nativity Church Bethlehem

September 2015

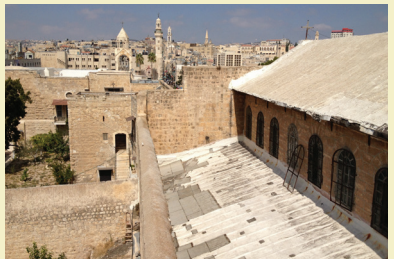
A detailed survey was conducted for the roof structural elements including trusses, purlins, boards..etc. to assess the level of damage/decay and the required level of intervention which included, maintenance, consolidation and in some cases replacement of some severely damaged parts. The structural intervention included also some seismic improvement measures, such as increasing the in-plane stiffness of the roof and improving the connection between the trusses and the masonry walls. The new roof system

was also designed and constructed to guarantee an effective internal ventilation and a durable waterproofing protection. The new installed windows will provide both waterproof efficiency and UV transparency to properly protect the mosaics and trusses. Moreover a lifeline system was introduced to provide safe access to the roof for the Church maintenance staff. The work in this Phase was completed in March 2015.

The roof and its wooden structures were for centuries in precarious conditions and in dire need for conservation. It was urgent to guarantee the stability of the roof and to prevent further damages to valuable wall mosaics and plasters, caused by years of rainwater infiltration. This was the first task to be tackled starting in September 2013 including the restoration of the upper wooden windows and the roof rain water drain network.

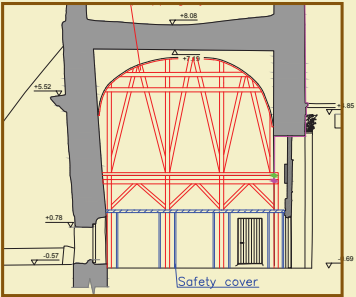
The intervention was a priority to protect the Church main entrance, which along with the roof represented the main elements of risk that led UNESCO to include the Church in the list of endangered sites. The archeological excavation above the three vaults of the Narthex was completed in November 2014 and an extensive documentation was collected. A detailed consolidation solution for the damaged vaults was developed on the basis of a detailed laser scanning survey that shows the deformed current status of the vaults, the analysis of the changes that occurred over the years to the bearing walls, the information obtained from the historical documentation, the tests on masonries and their components and finally the results of 3D numerical simulations of the structural behavior. The solution was approved and the restoration works, started in June 2015 and expected to be completed by December 2015.

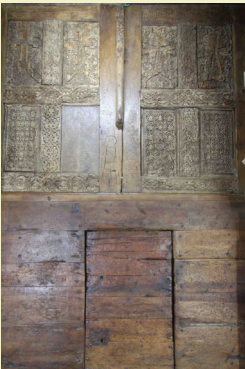
The restoration works for the narthex eastern wooden door started in September 2014 by performing high-resolution digital photographic documentation and diagnostic research. They continued with a careful consolidation and treatment process carried out by wood restoration specialists. During the works, a major finding was made as the original upper part of the door on the eastern side (internal side of the Church) was hidden by wooden boards. On the west side the restoration allows to fully appreciate the beauty of the original marquetry. The work was completed in December 2014 and both visitors and pilgrims can now truly admire the door in its original form.

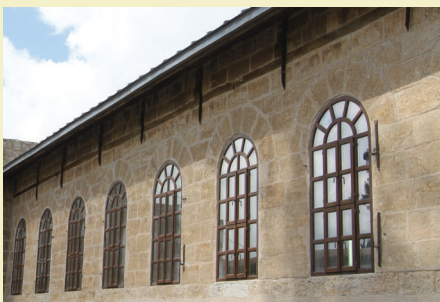
Two construction techniques were distinguished in the Basilica. The first is characterized by the use of large and perfectly squared ashlar blocks up to 1m long and to 0.4m high, set in parallel horizontal courses of fairly consistent but not invariably identical height. The second, is characterized by the use of roughly squared blocks of fairly modest dimensions, set in horizontal and parallel courses. The bedding joints vary in thickness up to 3cm.

The top priority was given to the restoration of the stone façades at the two corners and the lateral naves so as to avoid any damage to the lead roofing under construction. The restoration work included cleaning works, the replacement of sealing potland cement with lime and also the replacement of some severely eroded and deteriorated stone pieces. This work was completed in February 2015; the rest of the stone façades restoration works has been postponed to concentrate on priority tasks until securing the necessary funds.

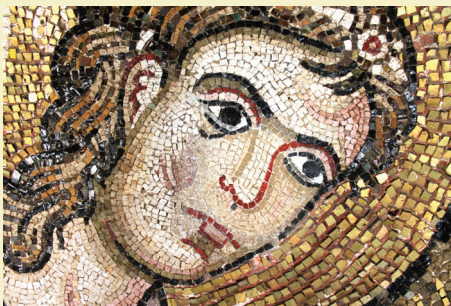
The existing mosaic surface is uniformly covered by an incoherent, or partially coherent, deposit of atmospheric particulate due to the deposit of the material carried by the percolation of rainwater coming from the roof. The detachment of the preparatory layers is the most severe and widespread morphology of damage, involving all mosaic surfaces.

The restoration works on the wall mosaics started in March 2015. A group of mosaics restoration specialists started the survey of the wall mosaics in the nave and performed preliminary evaluations and tests. During the survey, a new fragment of an angel on the north wall between the fourth and the fifth window was discovered. The preliminary cleaning works on all mosaics of the central nave was completed as well as considerable progress was made in their consolidation. The mosaic restoration in the central nave is expected to be completed by the end of the year whereas the one in the transept by mid-2016.
